Sand dune management problems and techniques, Spain.

Gregorio Gómez-Pina†, Juan J. Muñoz-Pérez‡, Jose L. Ramírez†, Carlos Ley∞

†Dirección General de Costas, Ministerio de Medio Ambiente, Plaza San Juan de la Cruz s/n, Madrid 28071, Spain, pyoggp@m.dgc.mma.es

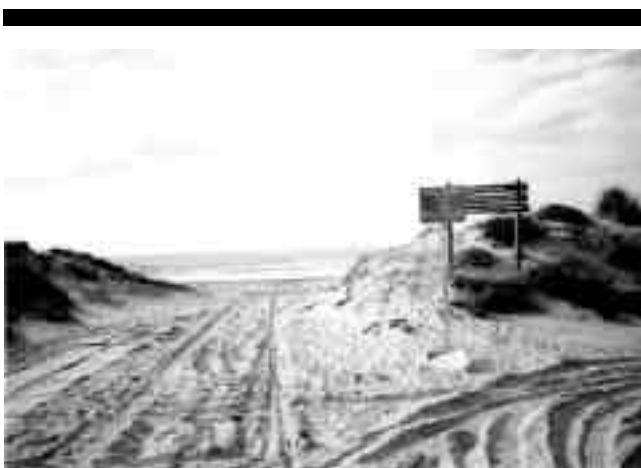
Figure 1. Typical dune breaching in La Bota (Huelva, Spain), Gómez-Pina 1997

Figures from GÓMEZ-PINA(1999) are representative of dune degradation in La Bota beach (Huelva). Figure 1 shows a typical dune breach caused by off-road vehicles and human trampling. Figure 2 depicts the existing public road, crossing the foredunes longitudinally. The removal of this road is part of a very ambitious integrated dune management project being carried out by the National Spanish Coast Directorate, Ministry of Environment.

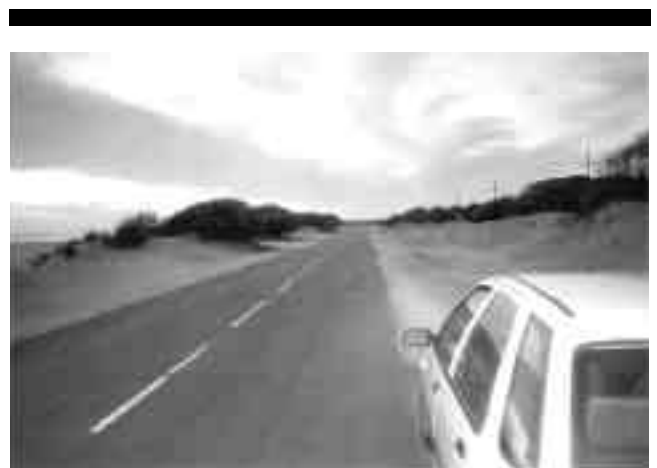
Figure 2. Existing road alongside La Bota beach (Huelva, Spain), Gómez-Pina 1997.

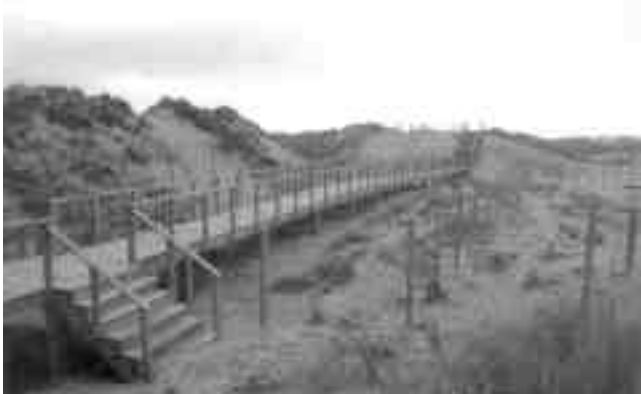
Figure 8. Dune walkover and fencing in Liencres spit (Cantabrian, Spain)

Figure 6 depicts an aerial view of Liencres spit after dune breaching. In Figure 7 sand accumulation caused by willow fences can be seen. Elevated dune walkovers and fencing are shown in Figure 8.

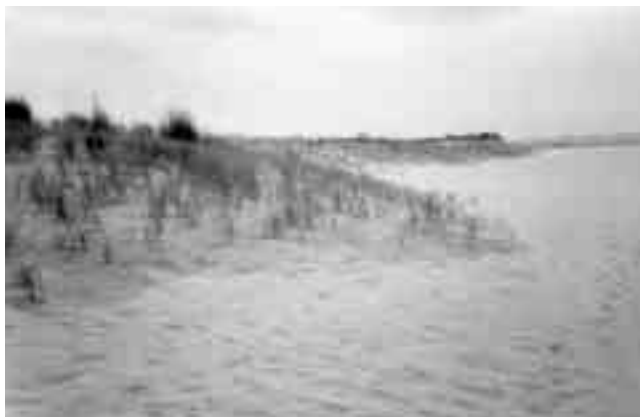
Figure 12. La Lanzada beach (Pontevedra, Spain) after dune restoration

Figures 11 and 12 show aerial views of La Lanzada beach before and after dune restoration.

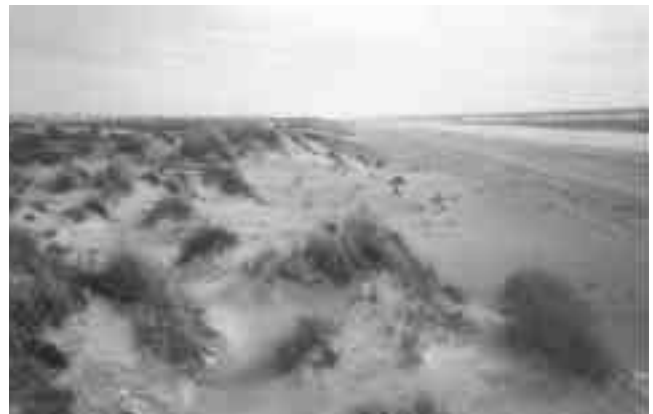
Figure 13. Dune blow-outs in Isla Cristina beach (Huelva, Spain)

Fig.13 shows typical dune blow-outs in Isla Cristina beach. Fig.14 depicts an illustrative grazing scene. Fig.15 shows dune fencing and revegetation.

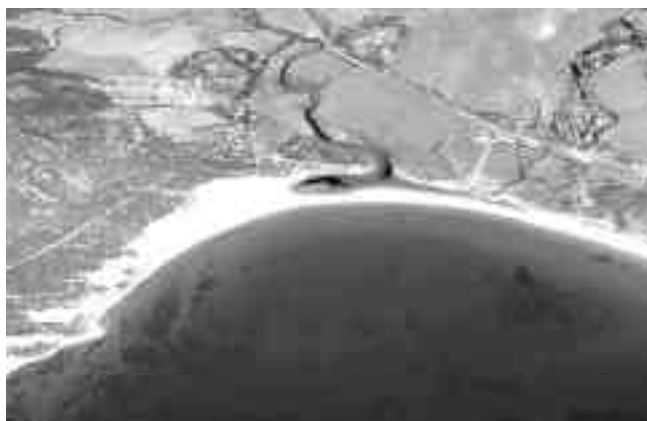
Figure 16. An aerial view of Valdevaqueros cove (Cádiz, Spain)

Figure 16 depicts an aerial view of Valdevaqueros cove. Figure 17 shows backdune restoration near the adjacent pine grove. Figure 18 shows foredune accretion after restoration.

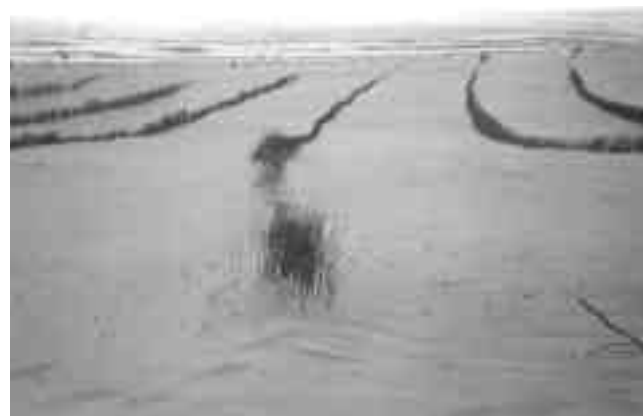
Figure 18. A view of Valdevaqueros accreted foredune after restoration (Cádiz, Spain)

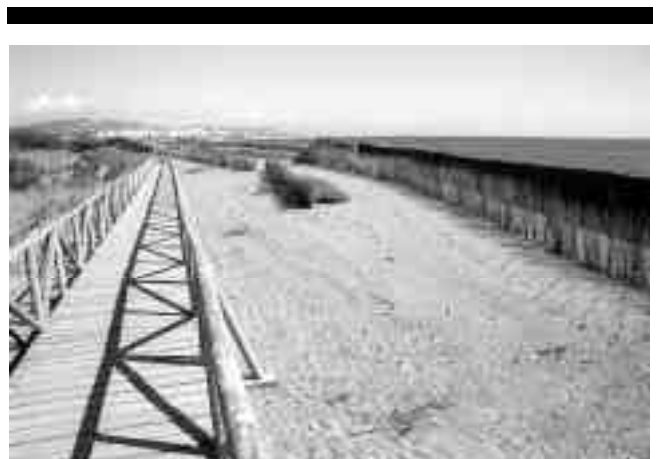
Figure 20. A detailed view of Guadalquítón dune restoration (Cádiz, Spain)

The dune restoration project was only a part of an integrated plan to improve coastal zone management aspects at the Guadiaro estuary, such as river flushing recovery, garbage cleaning, water quality improvement, wetland restoration, fencing of sensitive areas, public access improvement, sea bird observatories, beach nourishment and dune reinforcement. New sand trapping methods were experimented with as well as native transplanted vegetation under critical climatic conditions (yearly run-off is less than 250 mm)
